Rt. 83 and 22nd St <Eastbound and Southbound>

Oakbrook Terrace, IL RLR 1 Year Follow-Up

Evaluation Report

Reference No: 022-57459 July 2020 CASEY CALVELLO CHIEF OF POLICE

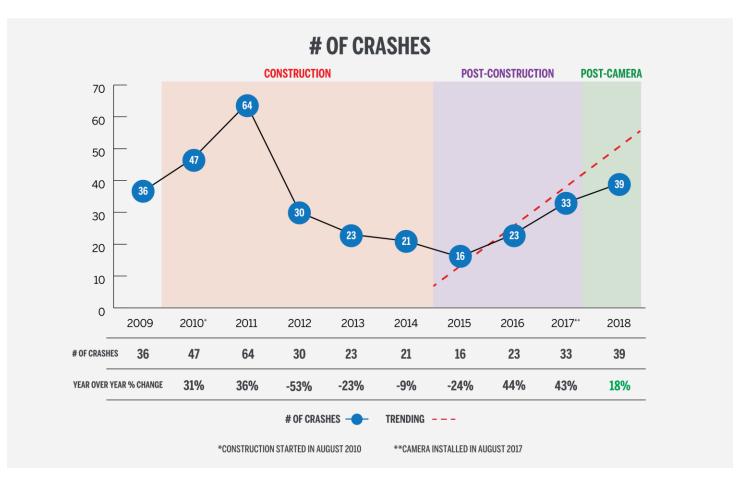
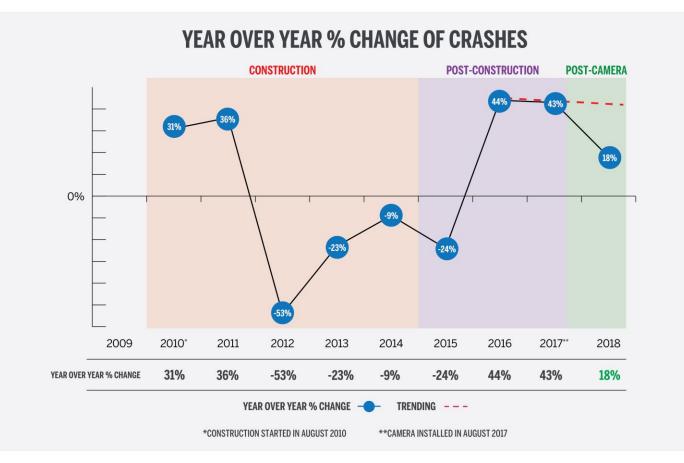
The table and charts below show a summary of motor vehicle crashes at the intersection of Rt. 83 and 22nd St over a span of 10 years.

Before In	stallation		-			After Installation
Year Type	2009	2010	2011	2012	2013	2014	2015	2016	2017	2018
Angle	1	0	1	0	2	0	0	0	3	1
Turning	10	12	21	5	2	3	3	8	6	12
Rear End	20	35	41	25	17	17	11	13	23	22
Other*	5	0	1	0	2	1	2	2	1	4
Total	36	47	64	30	23	21	16	23	33	39
Year-over-Year % Change		31%	36%	-53%	-23%	-9%	-24%	44%	43%	18%

According to IDOT, from 2010 to 2014, there were prolonged periods in which road construction contractors were solely responsible for Rt. 83 and 22nd St. During these periods (August 2010 - March 2012, May 2013 - September 2013 and March 2014 - October 2014), although crash data was reported, IDOT believed the data was not sound, and that because of the disruptions on the roadway it caused the crash data to be volatile, artificially lowering the number of crashes during this period. Once construction was over, however, it became apparent that the number of crashes began to rise - the crash data bore this out. In fact, the year over year trend in the number of pre-camera crashes (post construction) shows a 44% rise from 2015 - 2016 and a 43% rise from 2016 - 2017. After the installation of the RLR cameras, the rate of increase was only 18%, a reduction of 25%.

The declining year over year percentage change in the number of crashes demonstrates the positive impact RLR cameras have had since their 2017 implementation. Over the next several years, we expect the crash data to show a continued decrease in crashes at Rt. 83 and 22nd St. Because enhanced traffic safety is the principal aim of RLR camera enforcement programs, RLR camera systems should remain at this intersection as an integral part of a traffic system process that incorporates public education, enforcement and engineering.

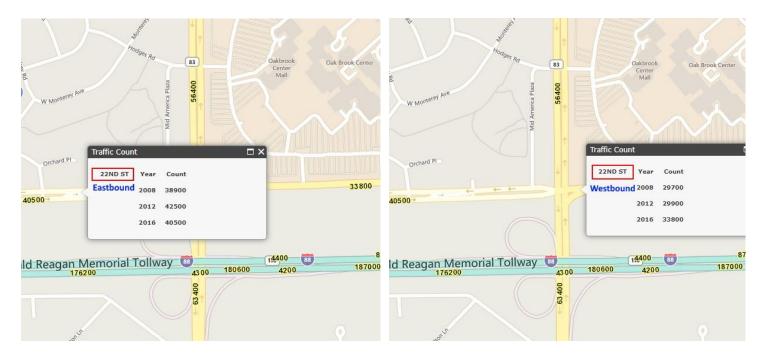
Eastbound and Westbound ADTC

The table below shows a summary of the Average Daily Traffic Count (ADTC) at the intersection of Rt. 83 and 22nd St over a span of 10 years.

The history of available ADTC on each approach was obtained from the IDOT website per the RLR Guideline document published by the IDOT and recorded in **bold** below. (<u>http://www.gettingaroundillinois.com/gai.htm?mt=aadt</u>)

From 2009 - 2016, prior to the RLR camera installation, the combined average of ADTC was 196,213.

In 2018, post RLR camera installation, the combined average of ADTC was 194,100, resulting in a decrease of 1.08% from the time period above.
